# AFTER THE CHAIN BREAKS

**Ray Hensley, Renold Jeffrey,** discusses causes and remedies for premature chain failure.

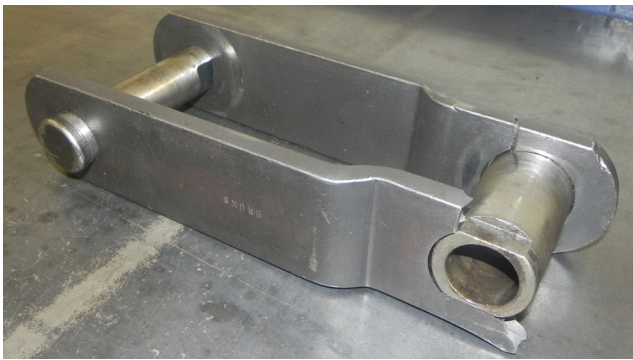
Figure 1. Sample as received.

One link of 5202-PB chain was received for analysis (Figure 1).

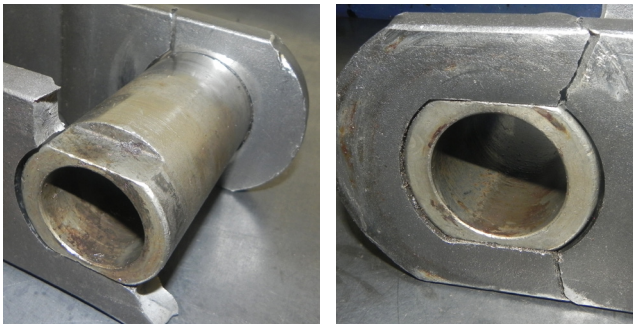
Figure 2. Fractured area on the head end offset bar (left); fractured area on the cotter end offset bar (right).

The returned link was visually inspected for any unusual wear conditions and points of failure. Both of the sidebars had cross sectional failures occurring in the area of the bushing (Figure 2). The inner surface of both sidebars had rubbing wear marks from the roller, but heavier wear was observed on the head end offset sidebar (Figure 3: left). The outer surface of the cotter end offset sidebar had some rubbing wear observed from the adjacent link (Figure 3: right).

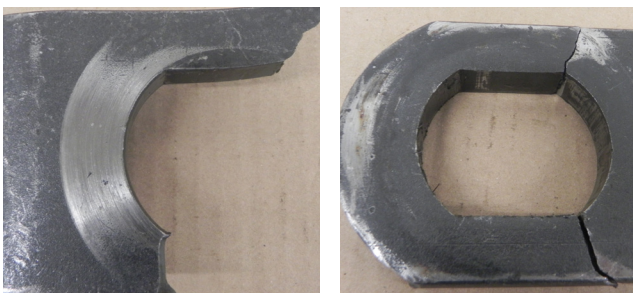
Figure 3. Rubbing wear from the roller on the inner surface of the head end sidebar (left); rubbing wear from contact with the adjacent sidebar on the outer surface of the cotter end sidebar (right).

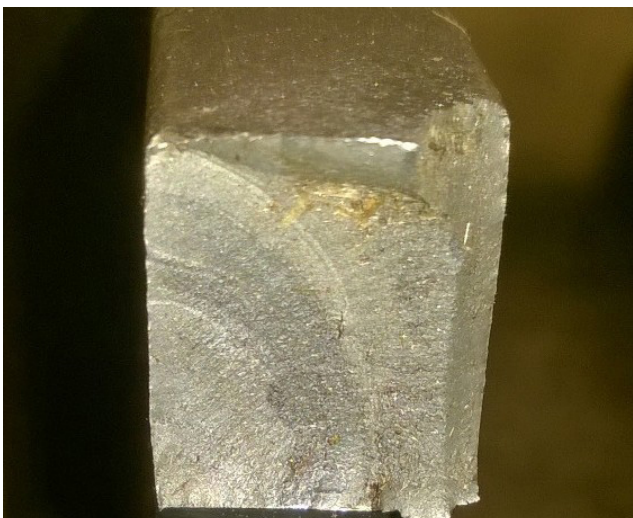
Figure 4. Evidence of long cycle fatigue followed by a fast fracture observed on the fracture surface of the head end sidebar.

The fracture surfaces of both sidebars were cleaned and examined. There was evidence of long cycle fatigue observed on the fracture surface of the head end sidebar at the pitch hole, beginning on the outer surface of the pitch hole and progressing inward through the cross section (Figure 4).

1. The plate failures appear to have originated on the head end offset bar at the pitch hole. There was evidence of long cycle fatigue beginning at the edge of the pitch hole on the outer surface of the bar and progressing inward through the cross section, followed by a rapid fracture.
2. The fractured cotter end offset bar appears to be a secondary failure condition.
3. The inner surface of the head end sidebar had rubbing wear present from the roller. In addition, rubbing wear from the adjacent sidebar was present on the outer surface of the cotter end sidebar. These conditions would suggest that the link was being forced to one side, which may have caused unusual stresses, resulting in failure of the sidebar through fatigue.

The cross section of the initial failure progressed through a fatigued mechanism until approximately half of the section remained. While not 100% accurate, this provides an estimation of the load at time of failure, indicating that the sidebar was seeing loads equivalent to a tensile force in the magnitude of half of the breaking load of the sidebar. This would put the equivalent tensile load on the chain in excess of 100 000 lb, while this chain has an expected 29 000 lb working load based on bearing area. It should be noted that the equivalent load might not be delivered directly through a pure tensile load on the chain. For example, if side loads are applied to the chain in the reclaimer, then the chain length between top and point of contact is effectively a giant lever arm, meaning high loads can generate stresses on the chain.

The bearings did not indicate continuous overloading in tensile conditions, so a sensible conclusion would be that the load was highly impulsive in nature, or the stress was applied through some mechanism that generated an equivalent tensile load of this magnitude in the sidebar. Based on the small sampling, it is possible the fatigue initiation was the result of temporary overload due to misalignment and/or repeating unnatural loading.

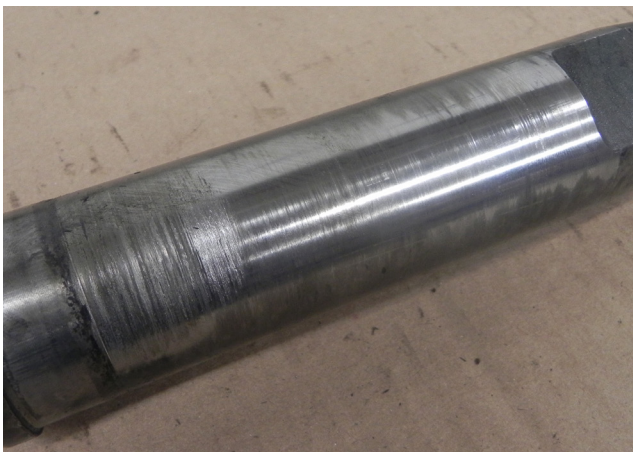
Measurements were taken across the bearing surfaces of the pin and bushing received. Minimal wear was present on the pins and bushings with areas of localised galling on the bearing surfaces (Figures 7 and 8). Table 1 summarises the results from this evaluation.

Figure 7. Localised galling on the head side of the pin was present on the bearing surface.

- The bearing surfaces of the pin and bushing had localised galling present on the head end side of the link. This condition may indicate uneven load on the chain, which could have caused unusual stresses to one side of the link and, over time, contributed to the sidebar fatigue failure.

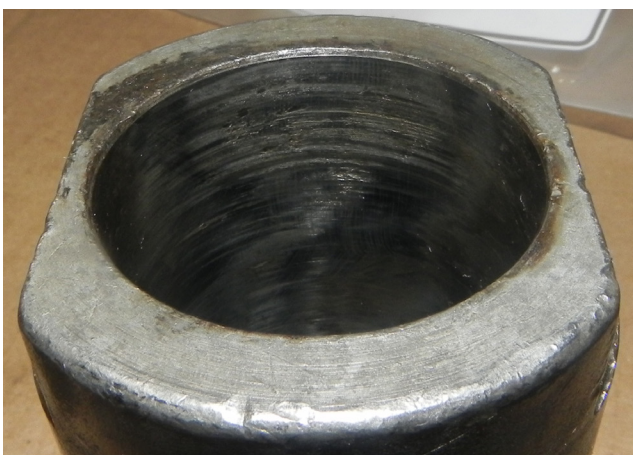
Figure 8. Localised galling on the ID of the chain bushing on the head side of the chain.

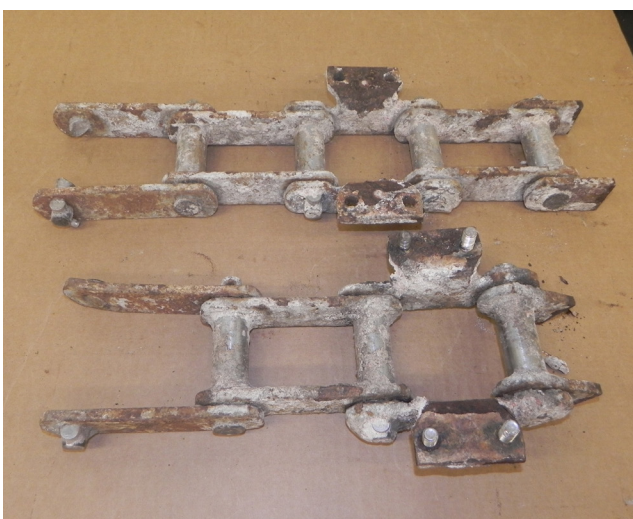
Figure 9. Sample as received.

SJ102 chain sections (Figure 9).

Two small sections of SJ102 chain with broken pins were received for failure analysis. Some stiff joints were observed in the returned samples and both sections were heavily covered in application material.

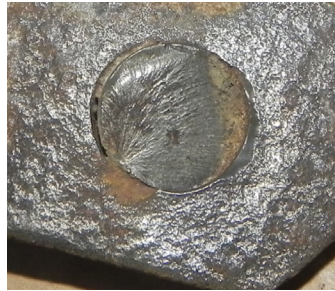
Figure 13. Corrosion pitting on the surface of the sidebar and evidence of torsional fatigue observed on the pin fracture surface on the head side.

Each of the components removed from the chain were cleaned for inspection. The sidebars were pitted from corrosion and some localised areas of pitting were observed on the pins. There was evidence of fatigue present on the fracture surfaces (Figure 13).

The pin fractures occurred on both ends of the pins at or near the shear zone area. The outer surface of the sidebars had heavy corrosion pitting present. One of the broken pins had some very light pitting observed near the fracture area surface. This could have introduced some stress cracks in the surface of the pin in this high stress location.

The fracture surfaces had evidence of fatigue present. Pin fatigue failures result from service loads that exceed the rated working load of the chain, or due to incorrect sprocket and chain interaction such as the chain climbing or clinging to the sprockets, which can result in high abnormal load conditions. In addition, the internal joint areas of both samples were packed with material leading to the tight joints observed. This condition could have caused unusual stresses to the pins which ultimately lead to failure.

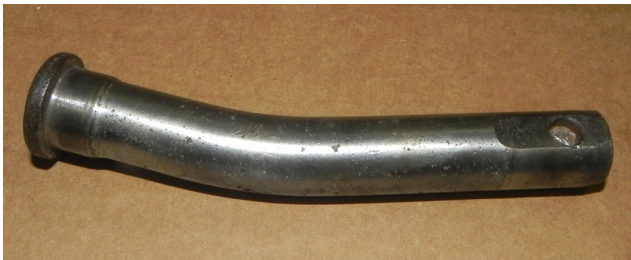
Figure 14. Typical condition of the pins tested showing sufficient ductility.

Surface and core hardness readings were within the specified hardness ranges (Table 2). Each of the pins that were bend tested had good ductility (Figure 14; Table 3).

The broken pins that could be tested were found to be within the specified surface and core hardness ranges. A bend test of the broken pins could not be conducted due to the short length of the pins. Bend test results on the unbroken pins showed sufficient ductility.
