Top of the CHAIN

Toby Imgrund, Renold,
discusses common engineered
chain assembly pitfalls.

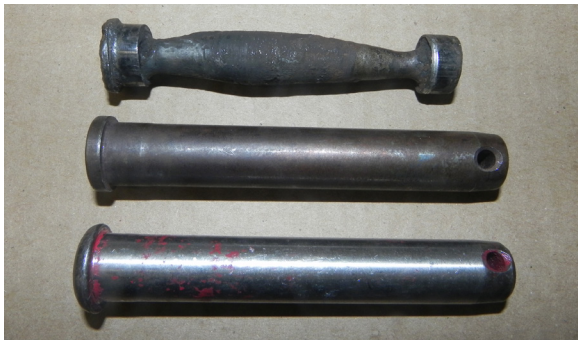
Figure 1. Pins can wear at varying rates. The topmost one is a carbon steel pin that was mistakenly assembled in a stainless steel chain.

If care is not taken during the disassembly and assembly process, chain components can become mixed, and old and new parts can become intermingled and assembled together. This presents a problem, as the interference fits between chains from different manufacturers is not the same. Misfits and improper components can cause rapid wear and void the manufacturer's warranty. As Figure 1 illustrates, these pins can wear at varying rates. The topmost pin shown is a carbon steel pin mistakenly assembled in a stainless steel chain.

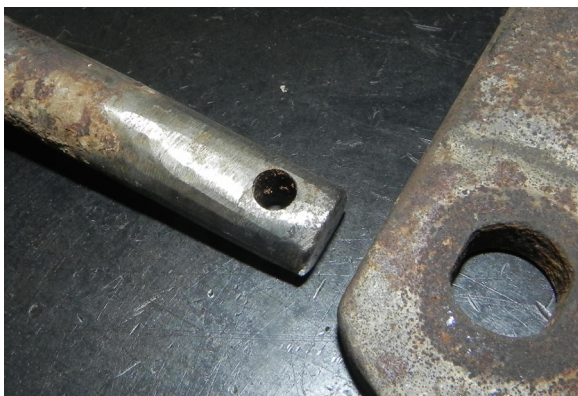
Figure 3. This pin was ground down to make the assembly process easier.

Grinding pins is another common mistake. Shaving even a few millimetres off a pin can mean the difference between a long-lasting chain and accelerated wear. At Renold, each Jeffrey engineered chain component is manufactured precisely to tolerances that are held to the thousandth millimetre. This provides an interference fit between the components. This interference fit is tight, and inherently makes assembling a chain more difficult. However, maintaining the press fit between the components is a key factor for increased chain wear life. Not only does a tight fit help keep abrasives like dust and debris out of the chain joint, but it also reduces friction. Less movement means less friction, which in turn means less wear and longer chain life (Figure 3). In this instance, the pin has been ground down to make the assembly process easier. When the installation crew ground down

these pins, they removed the hard exterior surface that protects the pin and joint components from abrasion. The chain wear life was drastically reduced as a result.

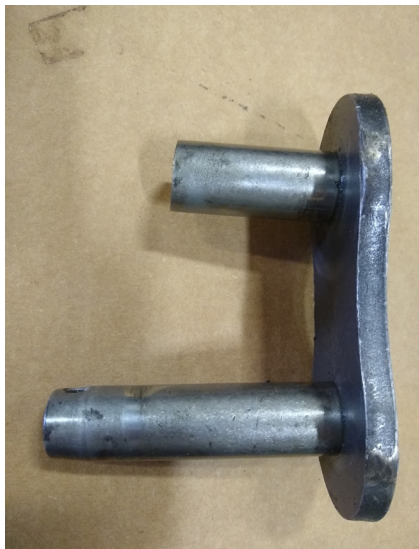
Figure 5. Chain components that were bent during the assembly process and caused the pin to shear.

As mentioned, hammering on steel chain components can be dangerous for those present and damaging for the chain being installed. Repetitive motion injuries, crushing and impact injuries, and puncture or scrap wounds from shrapnel all represent the physical results of manual assembly that can be avoided. Hammering away on chains can also cause deformation and bending of the components. Figure 5 illustrates an example in which chain components were bent in field assembly, which resulted in the pin shearing from the additional stress.

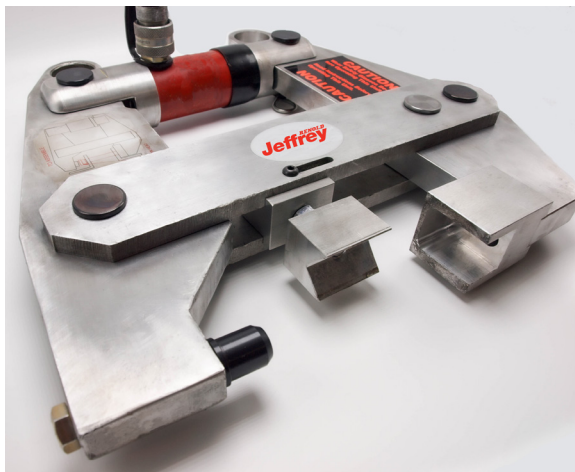
Figure 6. Renold Jeffrey's engineered chain breaker and assembly tool.

Due to all of the extenuating factors that go into chain assembly and disassembly, Renold now offers a Jeffrey engineered chain breaker and assembly tool (Figure 6). This tool addresses the issues discussed in this article. It removes the need for cumbersome hand tools, channel locks, hammers, and other undersized and unfit tools. Its aluminium body makes it a portable tool, weighing 26 lb. The simple design is intended for use with one operator, and a second person for stable positioning. In a continued effort for simplicity, the cylinder is fitted with a standard adaptor to couple with most hand pumps or related hydraulic sources.

In conjunction with safety, the tool allows for better product performance and maximises chain life as it provides a press fit pin. It also makes breaking chains apart much easier, meaning a faster turnaround time on replacement and installation overall. Each tool body can be used on a range of chain sizes using the adaptor kit, which consists of a sized insert and ram pin components, as well as manually adjusting the saddle. This tool was designed by experienced field engineers with a desire to make the process of chain installation and assembly easier, safer, and more efficient.
